TECHNICAL INSPECTION REPORT

(6) OPERATION CROSSROADS.  
U.S.S. NEVADA (BB36).

TEST BAKER [u] (8)

OPERATION CROSSROADS

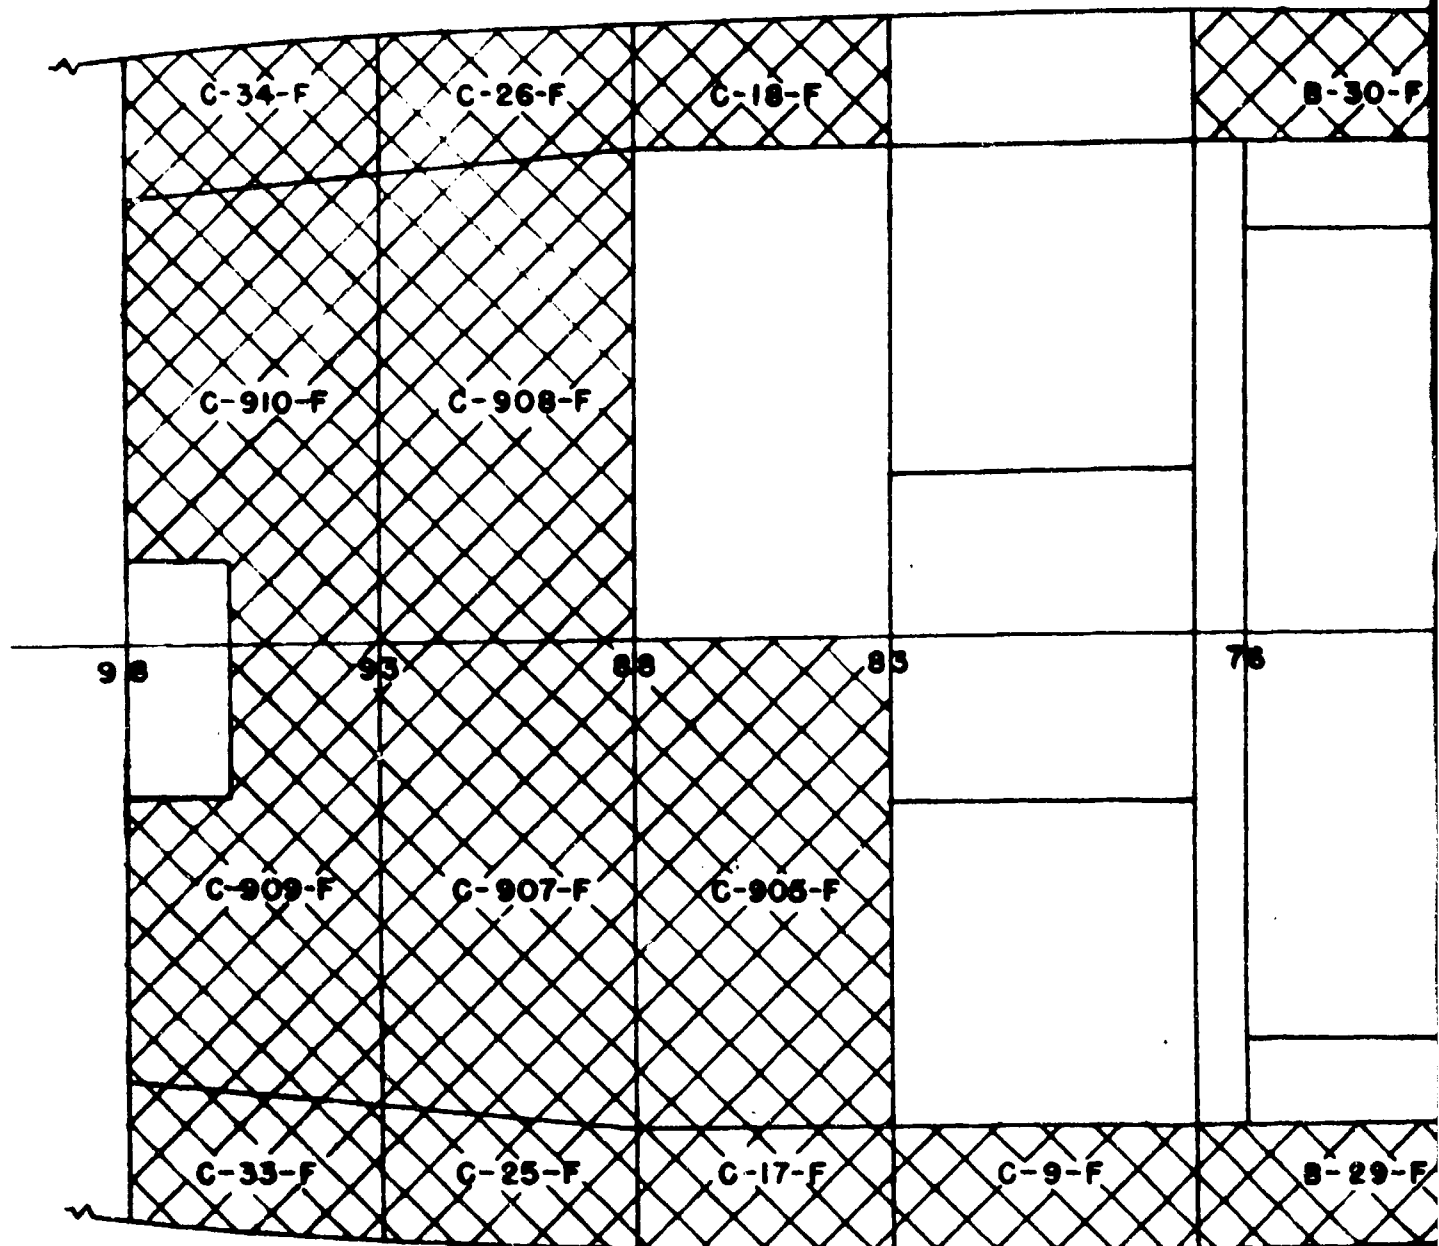
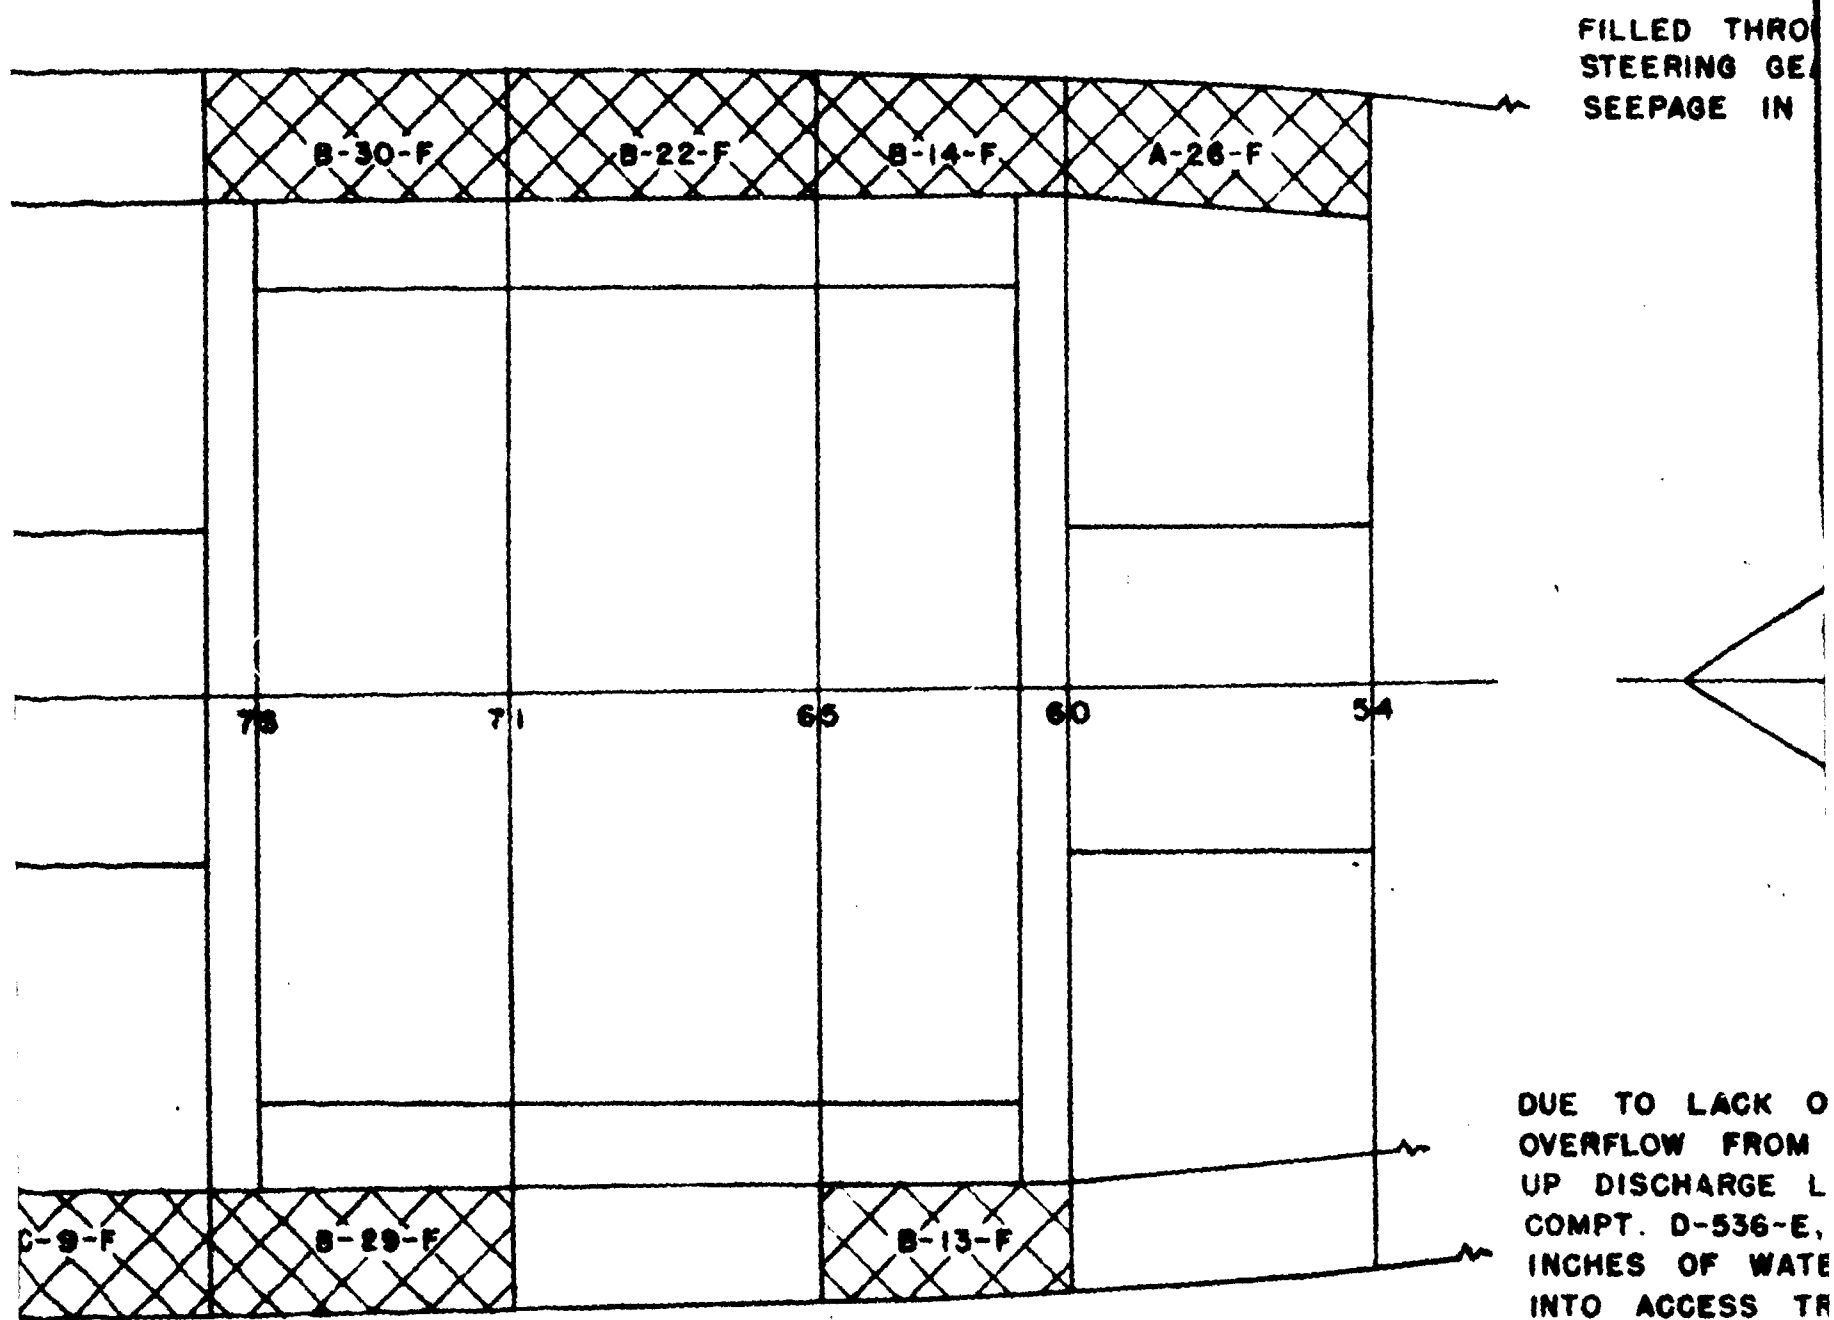
APPARENTLY DOUBLE BOTTOM TANKS  
FLOODED THROUGH SEAMS IN SHELL

DOUBLE BOTTOM TANKS  
ROUGH SEAMS IN SHELL.

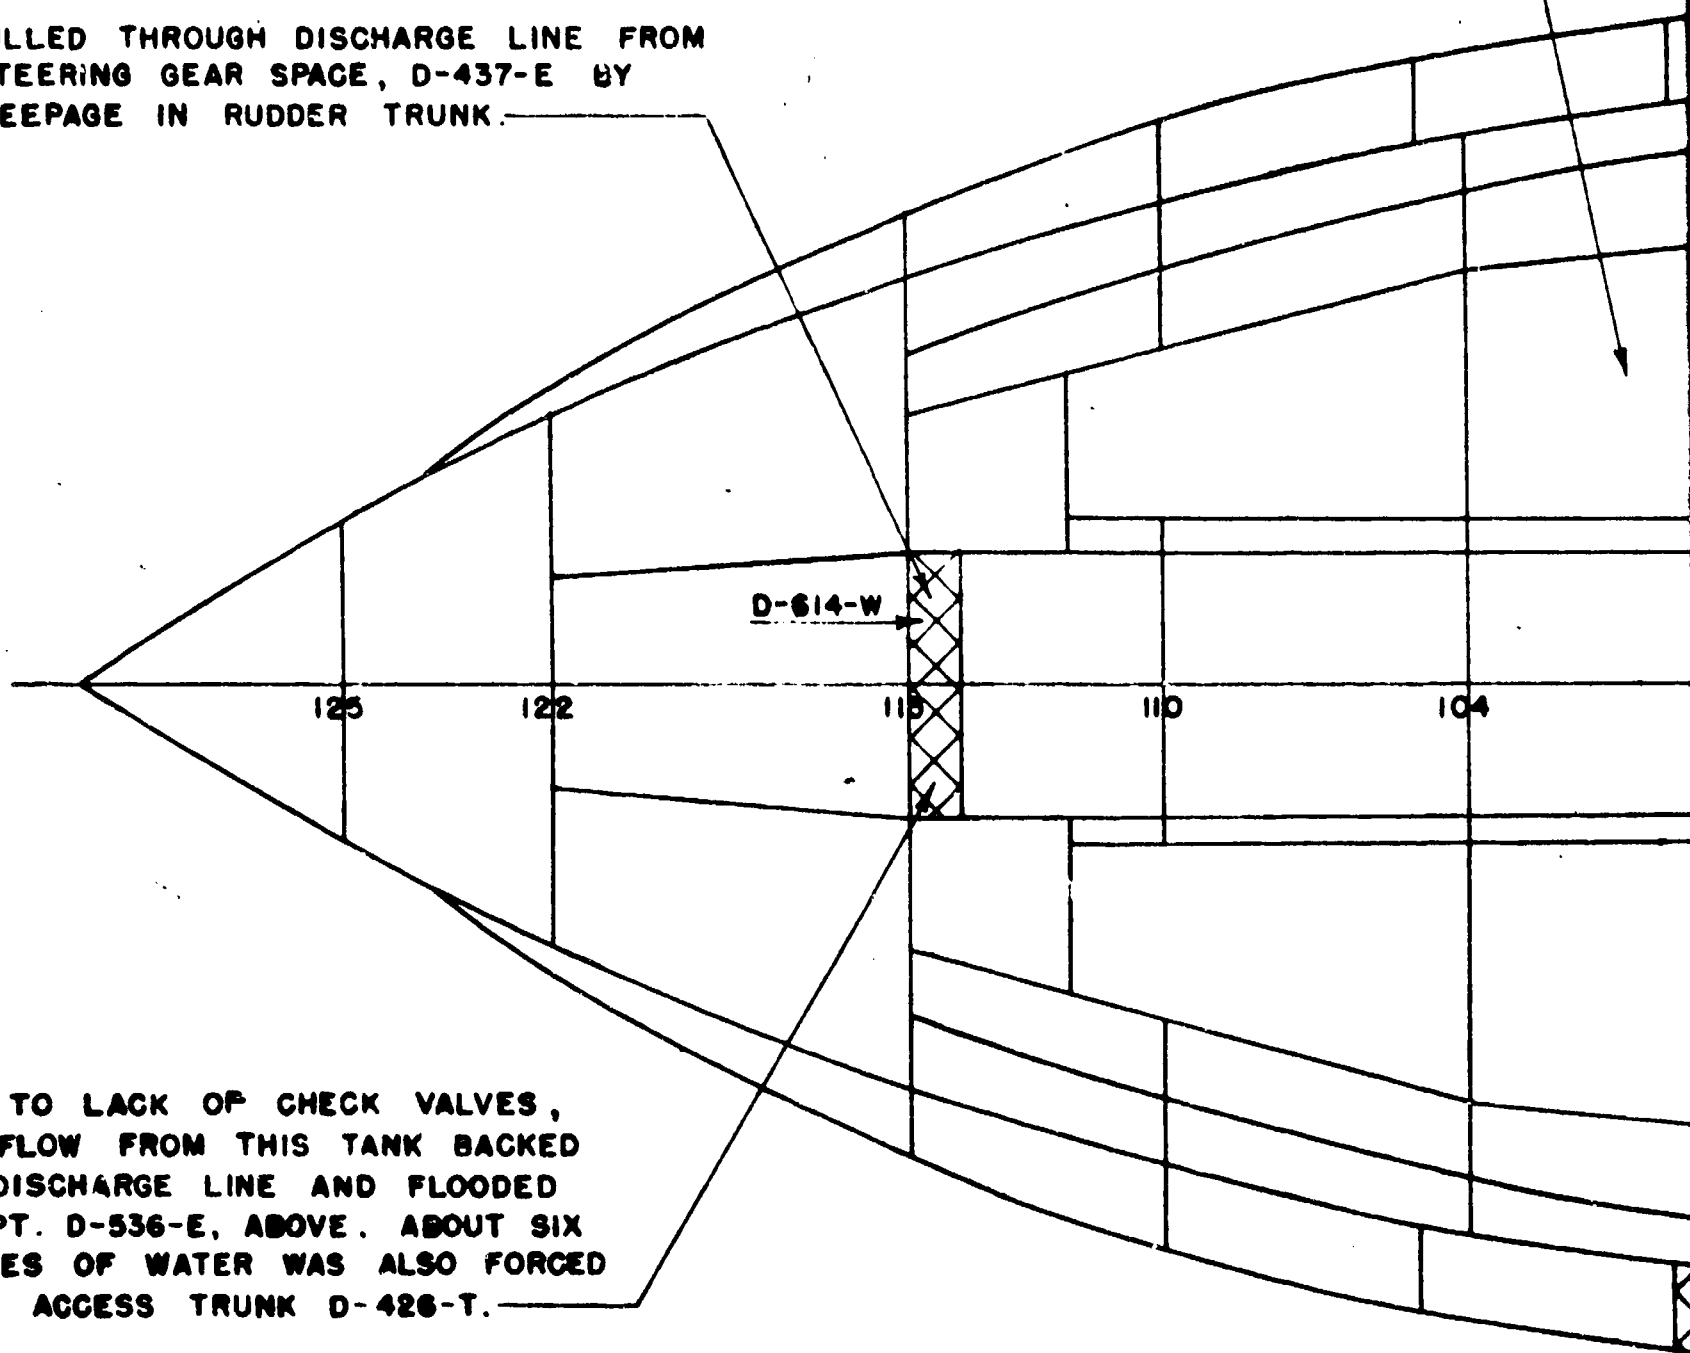
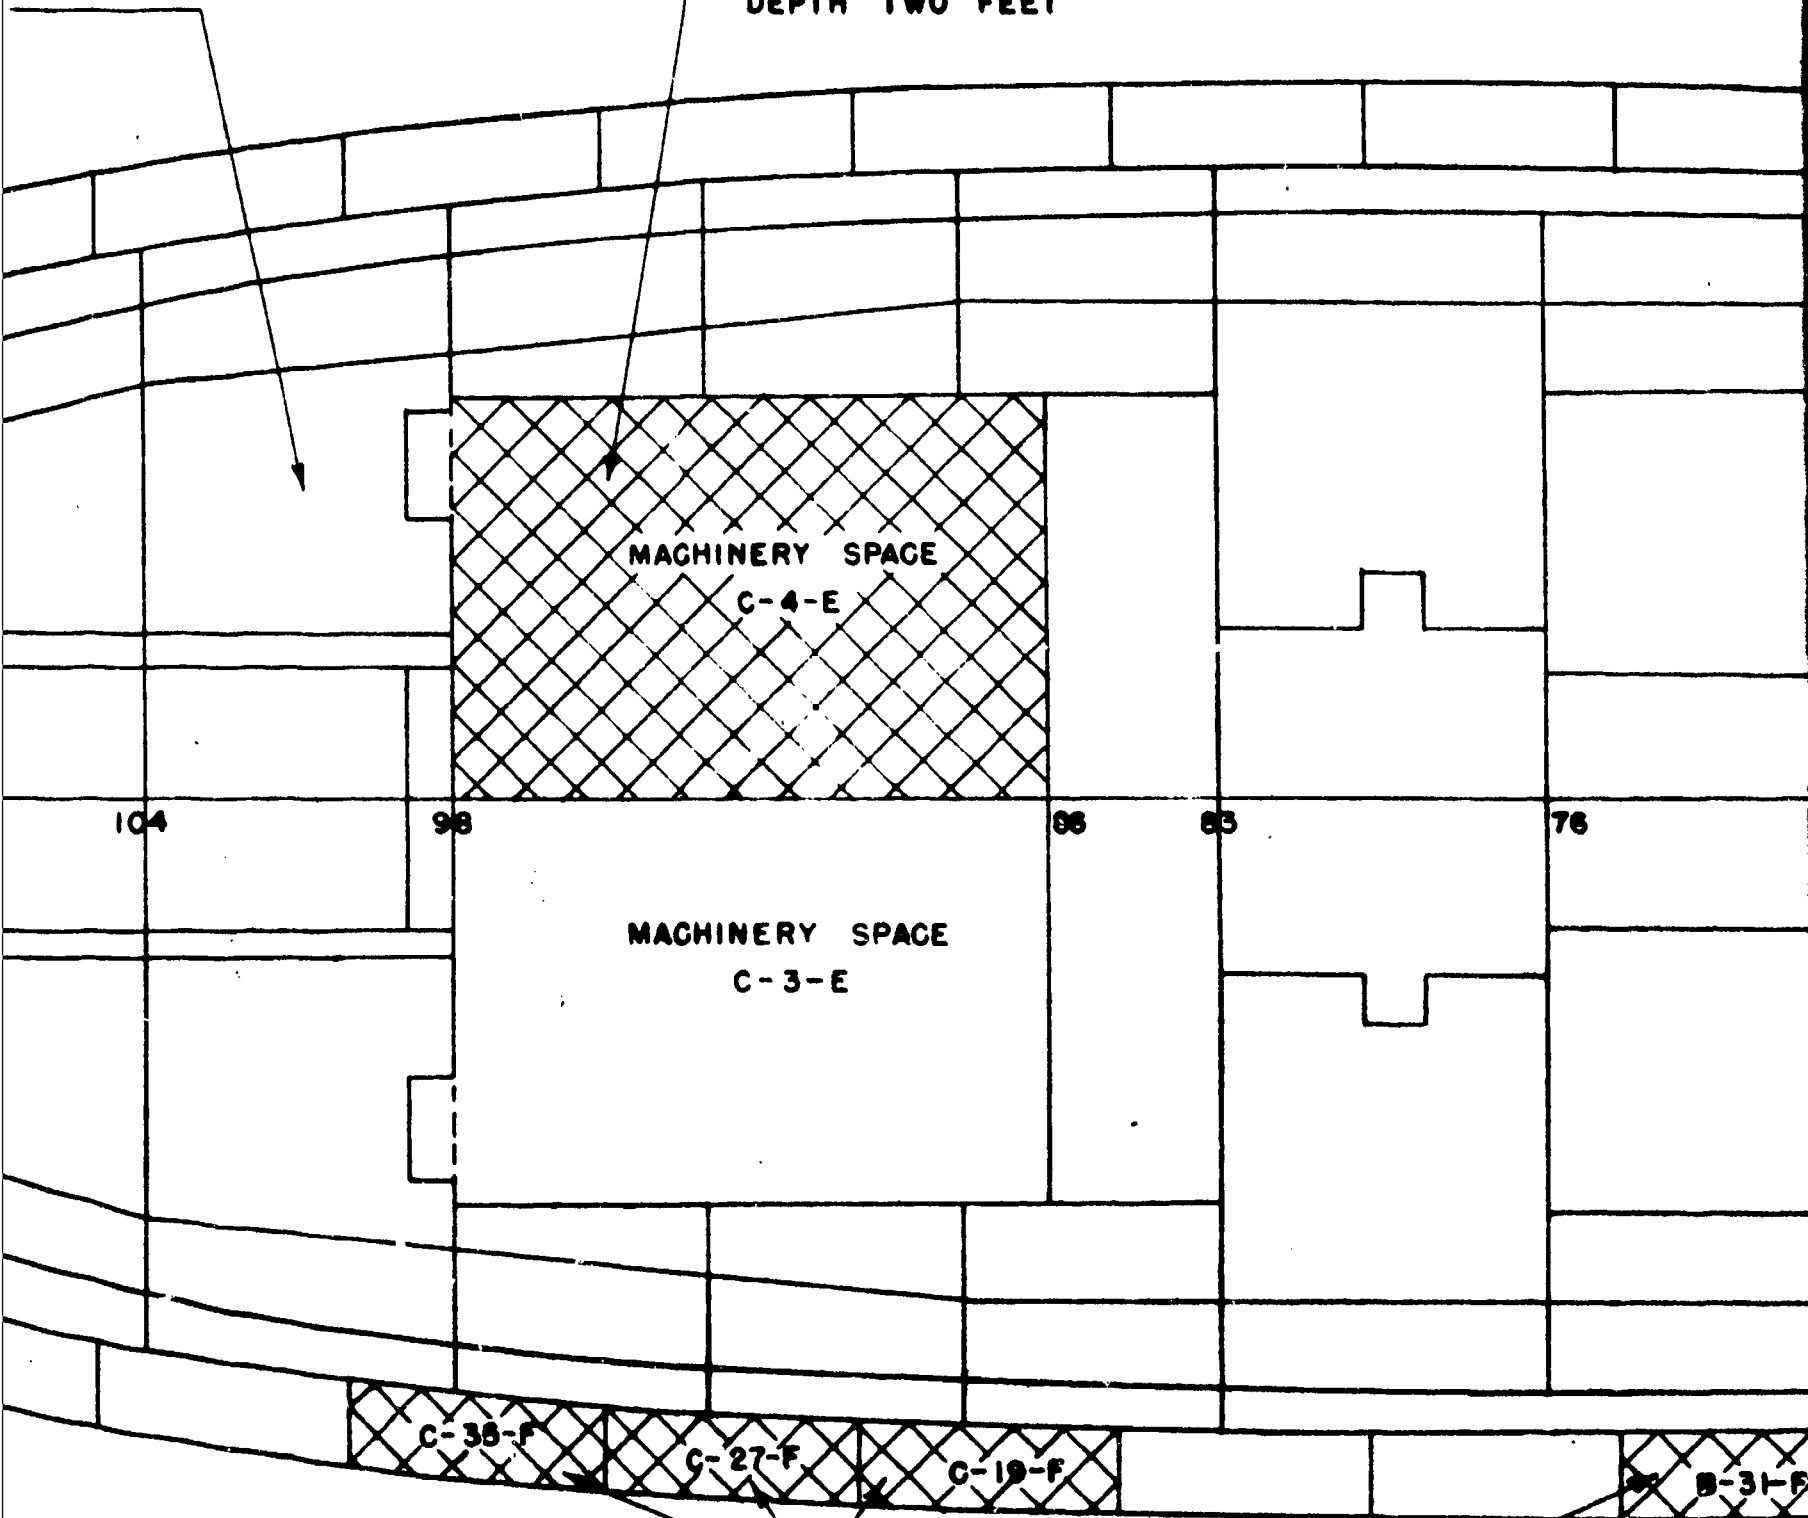
SIX INCHES OF WATER IN HANDLING RM.,  
D-407-B, ON 1ST. PLATFORM THROUGH  
CRACK IN DISCHARGE LINE.

FILLED THROUGH DISCHARGE LINE FROM  
STEERING GEAR SPACE, D-437-E BY  
SEEPAGE IN RUDDER TRUNK.

DUE TO LACK OF CHECK VALVES,  
OVERFLOW FROM THIS TANK BACKED  
UP DISCHARGE LINE AND FLOODED  
COMPT. D-536-E, ABOVE. ABOUT SIX  
INCHES OF WATER WAS ALSO FORCED  
INTO ACCESS TRUNK D-426-T.

FLOODED THROUGH CRACK IN  
OVERBOARD DISCHARGE LINE.  
DEPTH TWO FEET
